NAVORD REPORT 2932

INVESTIGATION OF MARK 18 TORPEDO FAILURES

25 AUGUST 1953

By:
Richard H. Stresau
L. E. Starr

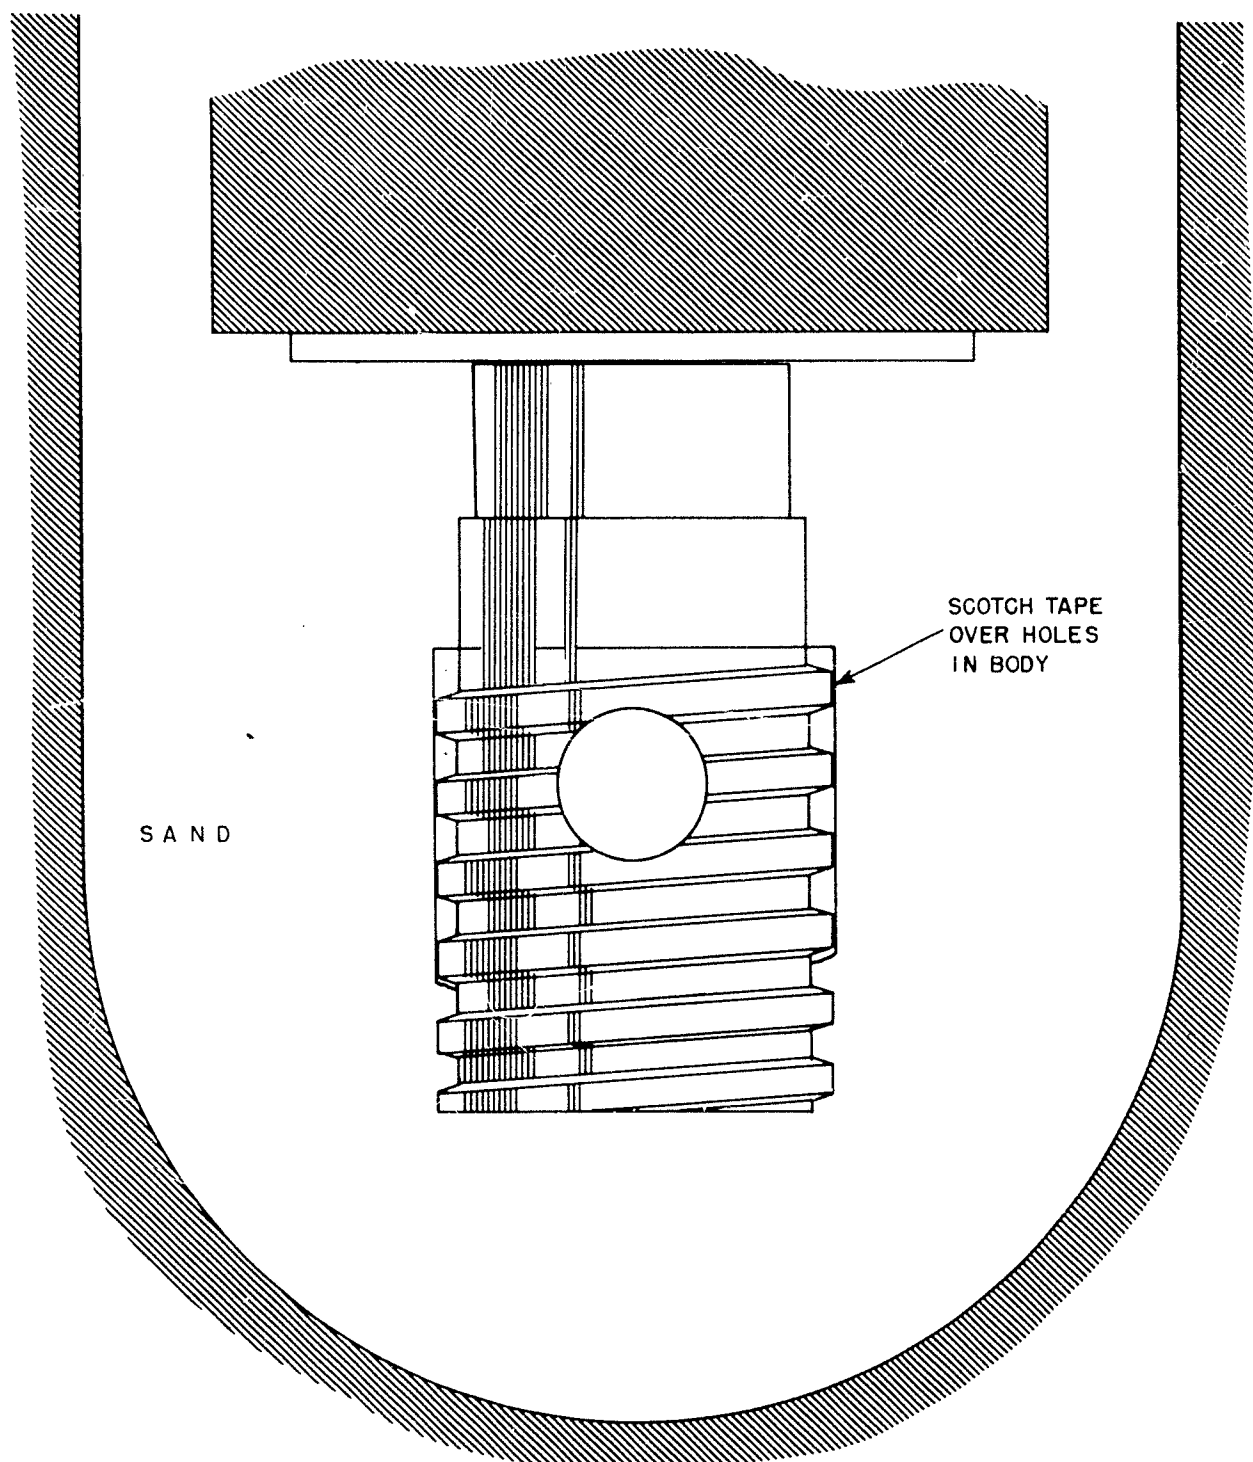
FIG.12 MK8 DETONATOR AS USED IN SPECIAL SAND TEST

24. One possible explanation for the good sand test results for detonators from the same group which produced low order detonation was that the sand afforded better confinement than the outer casing of the detonator which has four holes in the periphery and allows 1/16" or more clearance at the bottom in some instances. To check this possibility a series of sand tests was run with the detonators in their housings and with Scotch tape over the holes to prevent the sand from filling them and improving the confinement, Figure 12. The results of these tests are given in Table III.

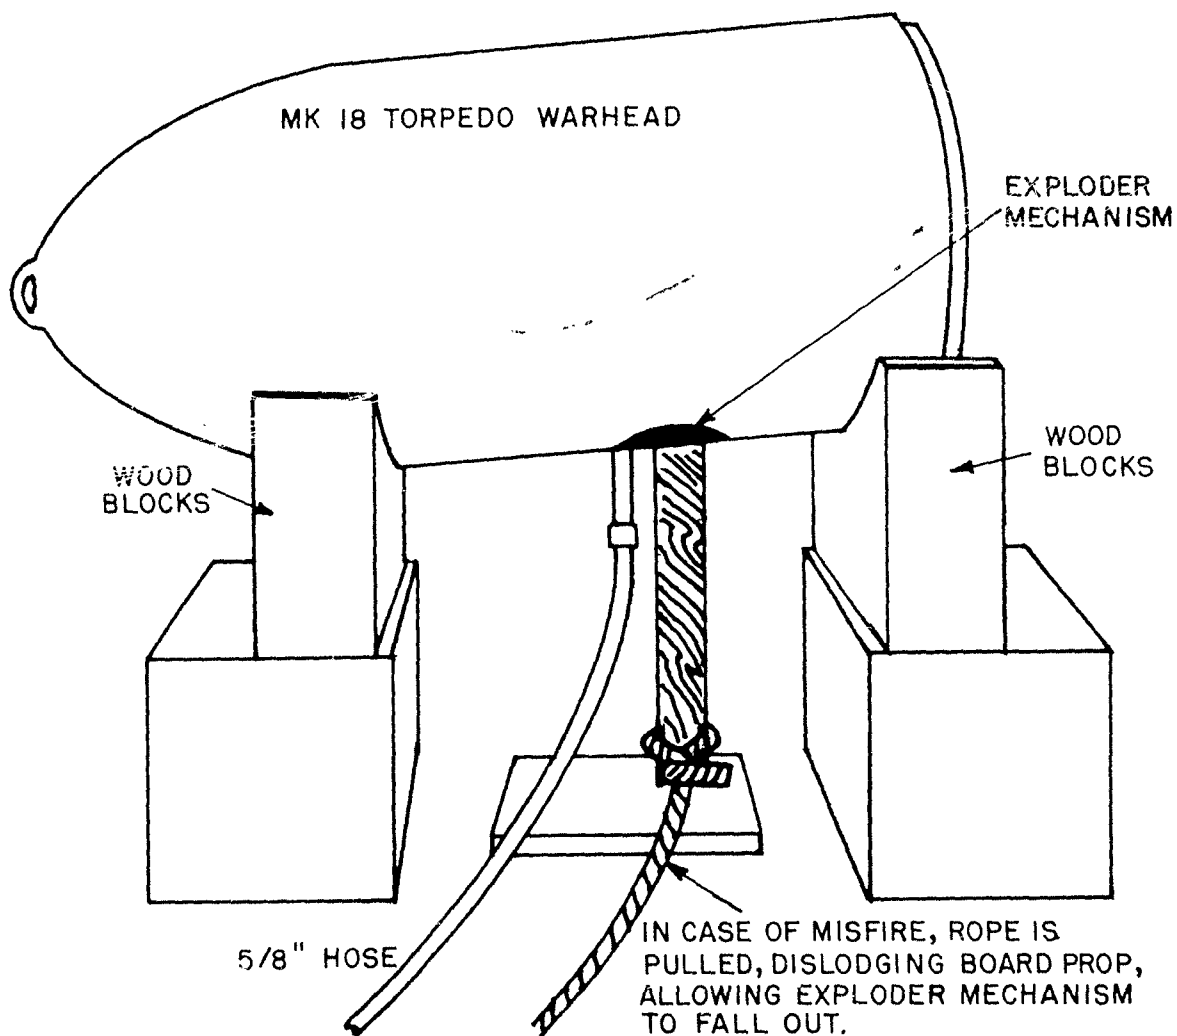
FIG. 14

25. A group of exploders, Mk 8 Mod 7, were modified as shown in Figure 13, and in more detail in reference (d), for use by the Naval Proving Ground, Dahlgren, Virginia, in fully loaded warheads. The modifications made it possible to arm and fire the exploders by means of water conducted to the mechanism by a hose. The water was pumped by means of a fire engine through about 1,000 feet of fire hose and 50 feet of garden hose. The garden hose was used for the last 50 feet because it was considered to be more expendible. The warheads were set up as shown in Figures 14 and 15 so that in case of a failure, the exploder could be removed from a distance by pulling the rope.
